Characterisation of damage development in single-shear bolted composite joints

V.P. Lawlor*, W.F. Stanley, M.A. McCarthy

Composites Research Centre
Mechanical and Aeronautical Engineering Department
University of Limerick, Limerick
Rep. of Ireland

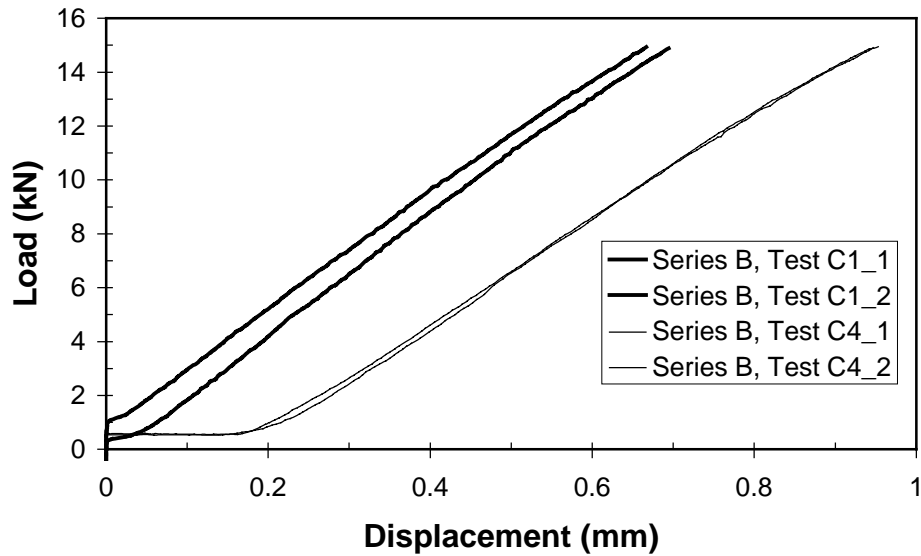
(b) Test series B – loading to 15kN

Figure 6 Force-deflection curves – note: C1_1 means C1 clearance, Test 1, etc.
